MODIFICATION OF THE DEVELOPMENT PROGRAM Development District No. 1

TAX INCREMENT FINANCING PLAN Establishment of the Tax Increment Financing District No. 1-8 (redevelopment district)

City of Lindstrom, Chisago County, Minnesota

Report of Inspection Procedures and Results for
Determining Qualifications of a
Tax Increment Financing District as a Redevelopment District

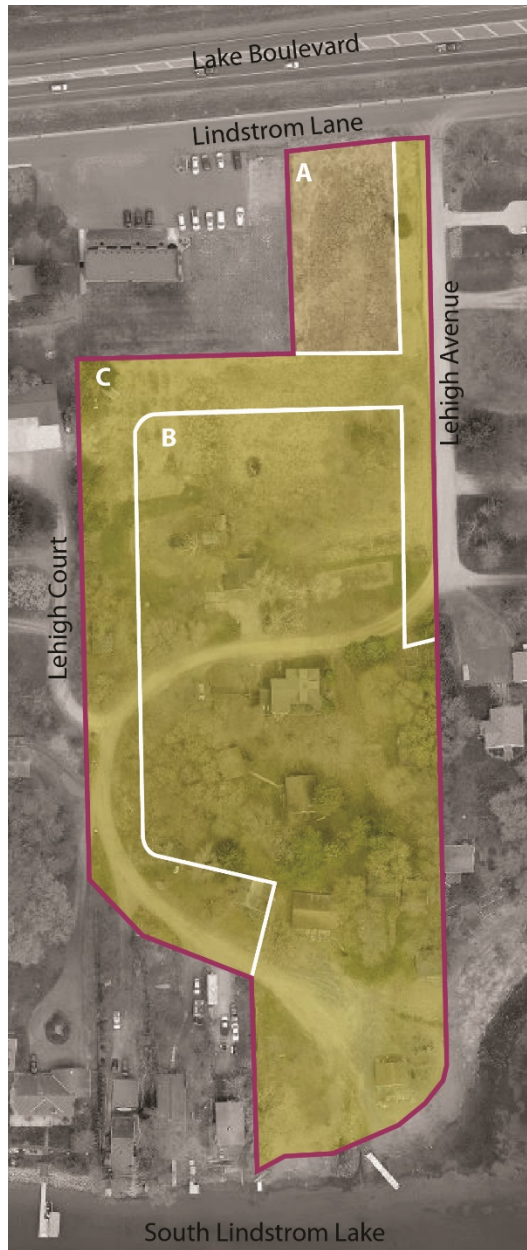
Diagram 2 – Coverage Diagram

The proposed TIF District met the coverage test under *Minnesota Statutes, Section 469.174, Subdivision 10(e)*, which resulted in parcels consisting of 91.9 percent of the area of the proposed TIF District being occupied by buildings, streets, utilities, paved or gravel parking lots, or other similar structures (Diagram 2). This exceeds the 70 percent area coverage requirement for the proposed TIF District under *Minnesota Statutes, Section 469.174, Subdivision (a) (1)*.

Shaded area depicts a parcel more than 15 percent occupied by buildings, streets, utilities, paved or gravel parking lots or other similar structures

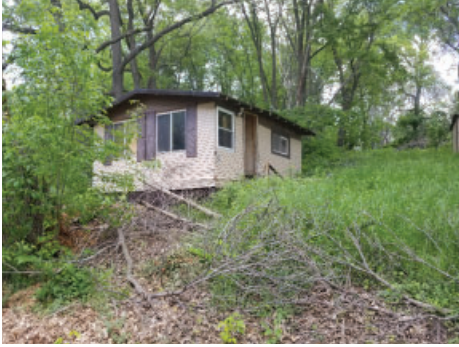
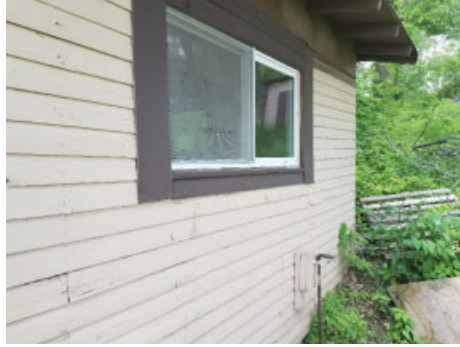
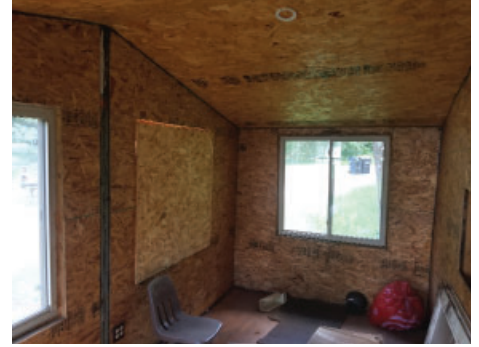
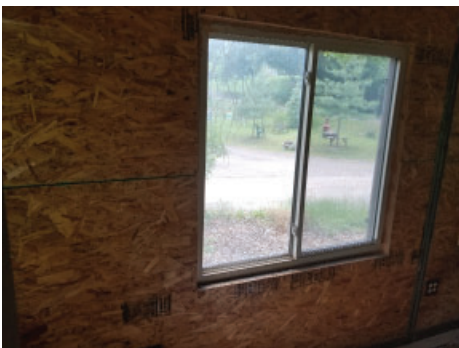
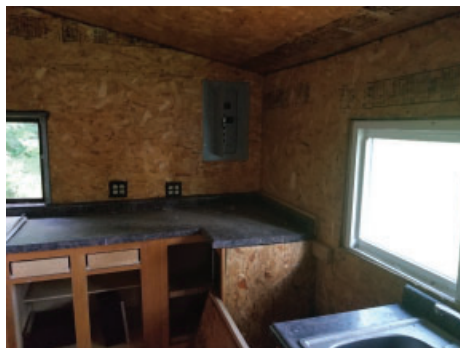
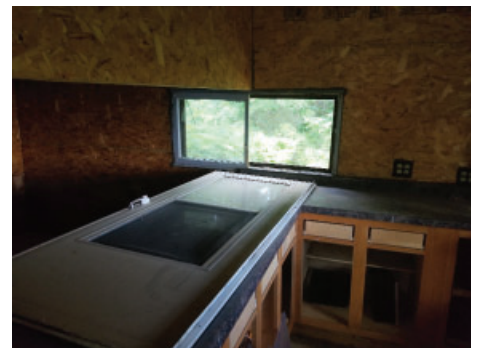
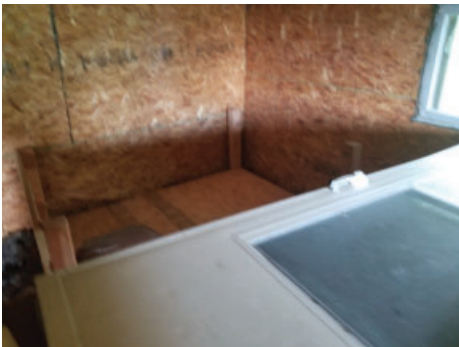
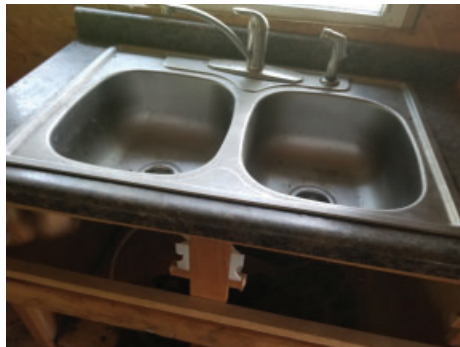
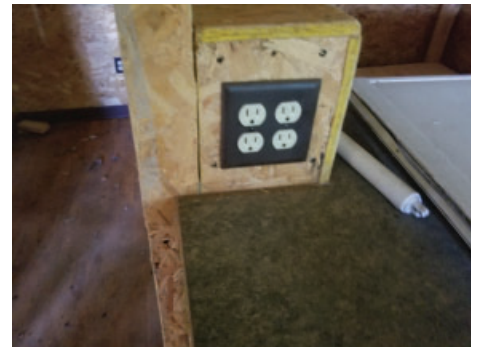
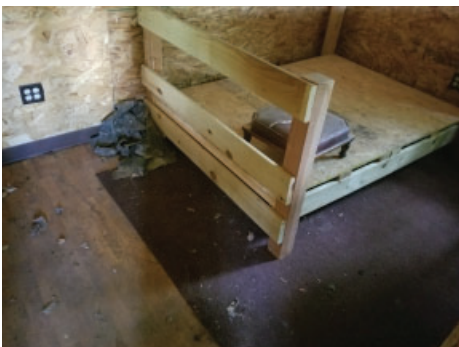
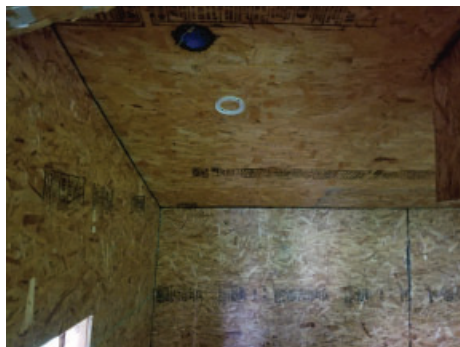
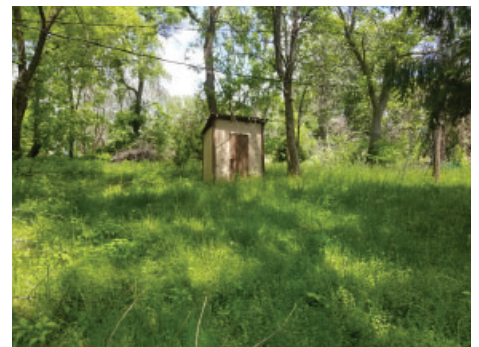
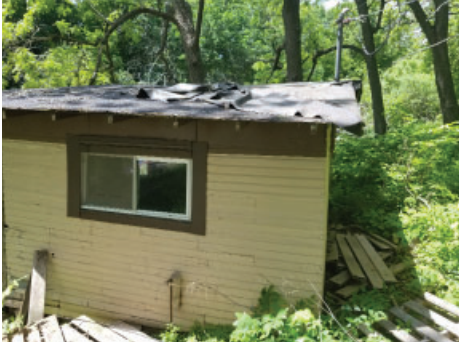
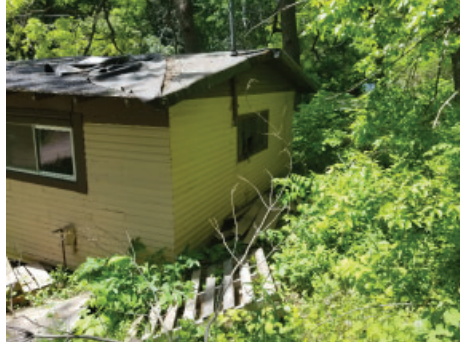
Photos: Parcel B, Building B1 - Cabin

- e. There is no code-required adequate egress from the building.
4. Layout and Condition of Interior Partitions/Materials
 - a. Flooring is rotting and soft.

5. Exterior Construction
 - a. Siding is rotting, allowing for water intrusion, contrary to code.
 - b. Windows have failed, allowing for water intrusion, contrary to code.
 - c. Roofing material has failed, allowing for water intrusion, contrary to code.
 - d. There is no exterior door, allowing for water intrusion, contrary to code.

This one room cabin has been unused for several years. The exterior surfaces are compromised, allowing for water intrusion, contrary to code. There is no adequate egress from the building, which is contrary to code. Code-required electrical and potable water service should be connected to the building. Windows and roofing systems have failed, allowing for water intrusion, contrary to code. There are no code-required smoke or carbon monoxide detectors in the building. There are no code-required GFCI's or AFCI's in the building. Interior surfaces should be painted and the flooring is bare wood. The kitchen system is nonfunctioning. There is no code-required heating system.

1. Code-required potable water should be connected to the building.
2. Code-required electrical service should be connected to the building.
3. Code-required toilet facilities should be installed.
4. Lighting is not code-compliant.
5. The HVAC system is not code-compliant.
6. Code-required smoke detectors should be installed.
7. Code-required carbon monoxide detectors should be installed.
8. Code-required GFCI's should be installed.
9. Code-required AFCI's should be installed.
10. A code-required adequate egress should be created.
11. Siding should be repaired/replaced to prevent water intrusion, per code.
12. Failed windows should be replaced to prevent water intrusion, per code.
13. Failed roofing material should be removed/replaced to prevent water intrusion, per code.
14. An exterior door should be installed to prevent water intrusion, per code.

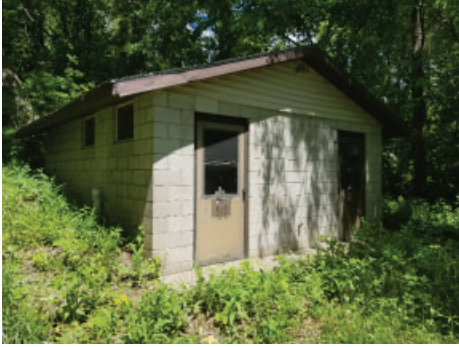
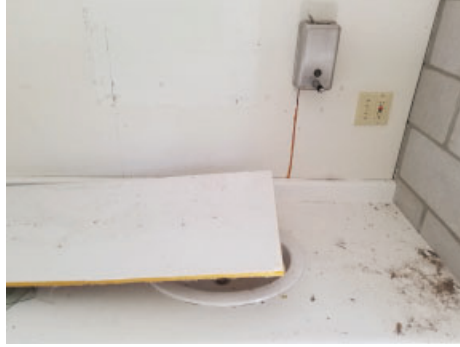
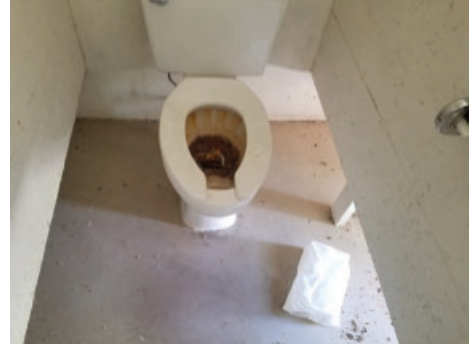
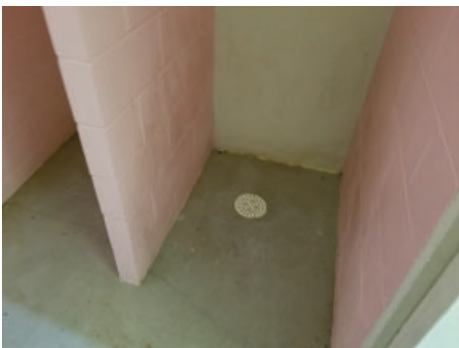
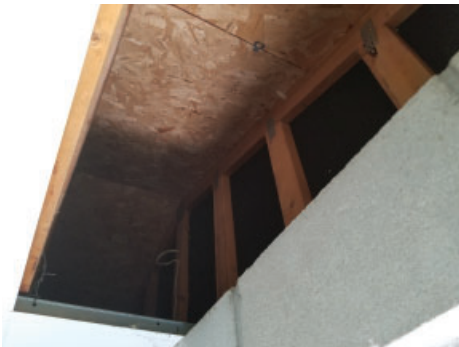
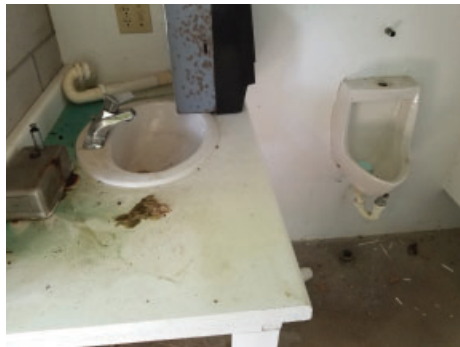
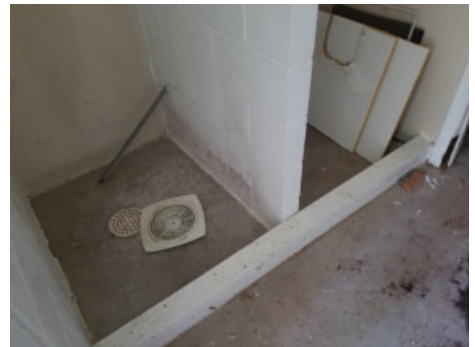
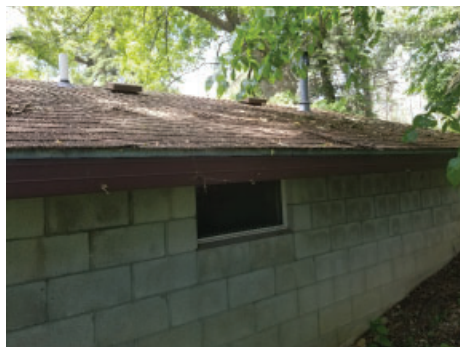
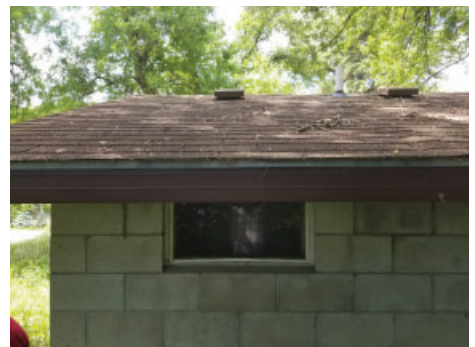
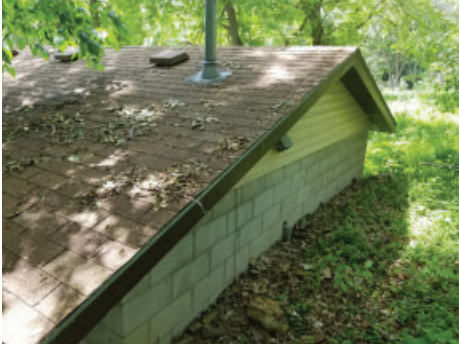
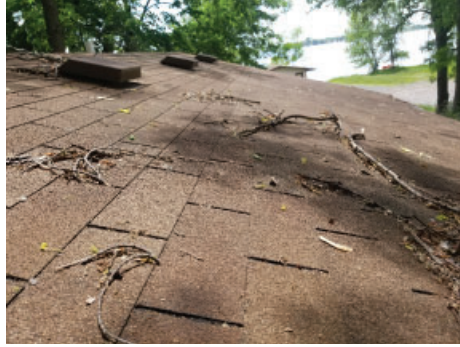
Photos: Parcel B, Building B2 - Restroom-Shower

4. Layout and Condition of Interior Partitions/Materials
 - a. Interior walls should be painted.
 - b. Ceiling should be repaired/replaced.
5. Exterior Construction
 - a. Roofing material has failed, and should be replaced to prevent water intrusion, per code.

This resort restroom/shower facility has not been used in several years and code-required potable water and electrical service has been shut off. The exterior block walls should be protected. There is no code-required accessible route into the building. There is no code-compliant toilet or shower in the building. Interior walls should be repainted. Ceiling tile should be repaired/replaced. The HVAC and lighting systems do not comply with code. Roofing material is failing, allowing for water intrusion, contrary to code.

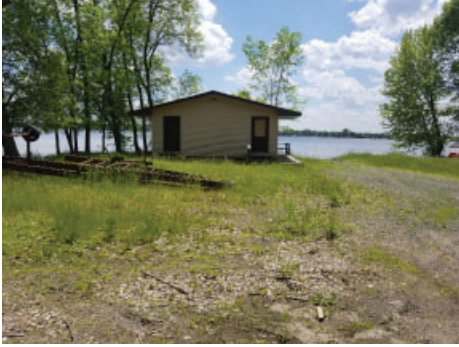
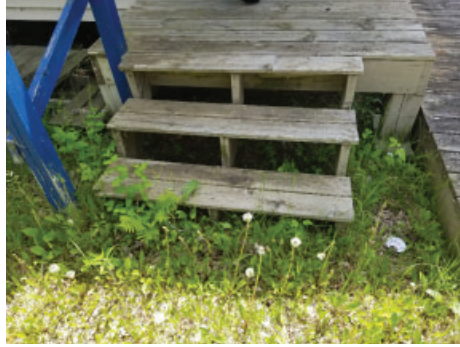
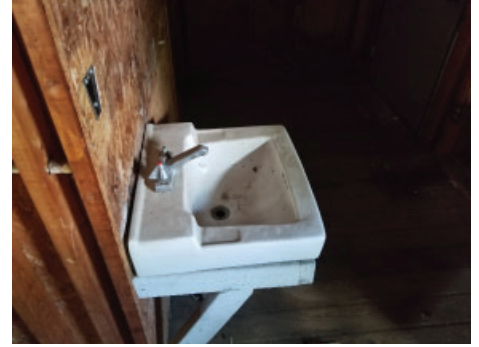
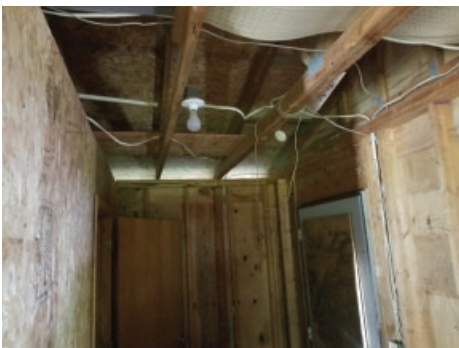
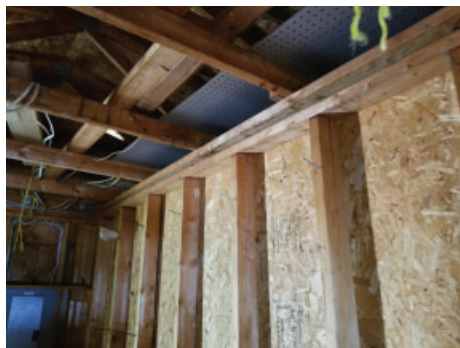
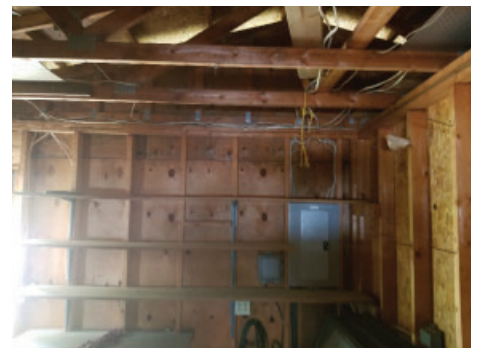
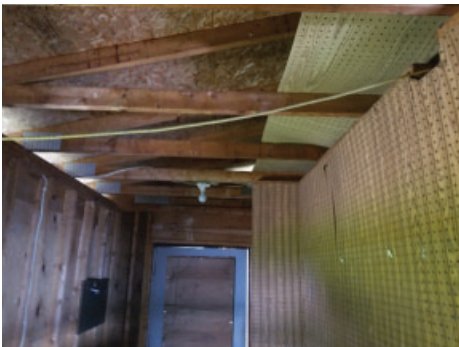
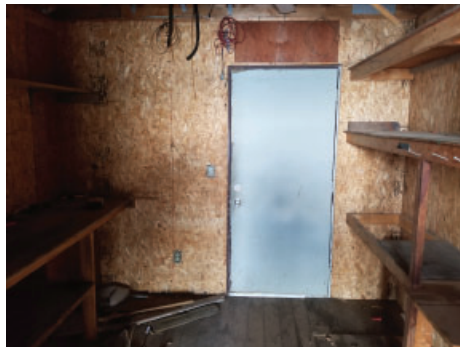
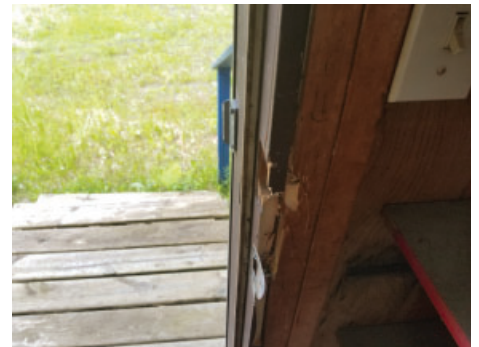
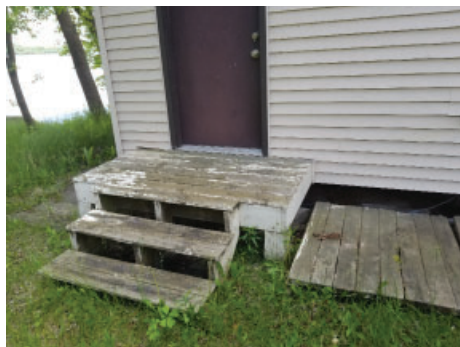
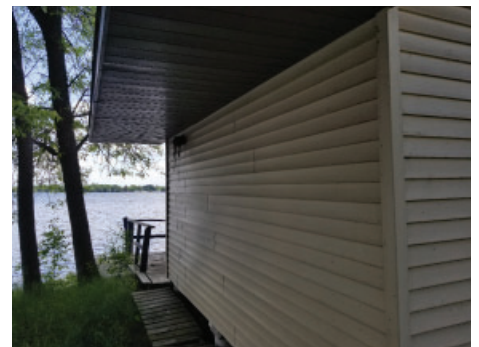
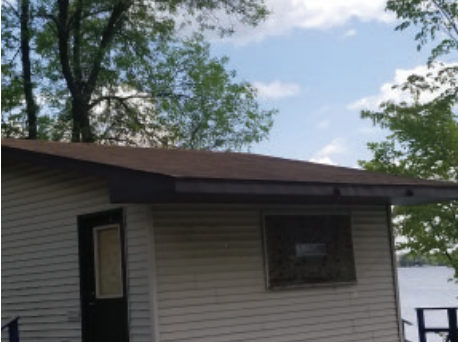
Photos: Parcel B, Building B3 - Office

4. Layout and Condition of Interior Partitions/Materials
 - a. Interior walls should be painted.
 - b. Ceiling should be painted.
5. Exterior Construction
 - a. Roofing material has failed, and should be replaced to prevent water intrusion, per code.
 - b. Windows have failed, allowing for water intrusion, contrary to code.

This building was used as a resort office and storage facility. There is no code-required accessible parking or accessible route into the building. The interior is bare walls with no insulation. There is no code-required electrical service to the building or potable water. Interior should be painted. There is no code-required toilet facility. There are no code-required life safety systems in the building. Roofing material should be replaced to prevent water intrusion, per code. Windows should be replaced to prevent water intrusion, per code.

14. Code-required emergency lighting should be installed.
15. Code-required emergency notification system should be installed.
16. Roofing material should be replaced to prevent water intrusion, per code.

17. Windows should be replaced to prevent water intrusion, per code.
